# Manhole Inspection Summary

Manhole # S43E\_\_051MH

Insp Date: **6/9/08 2:24 PM**

**Location** Address: **1608 e fairmount st**

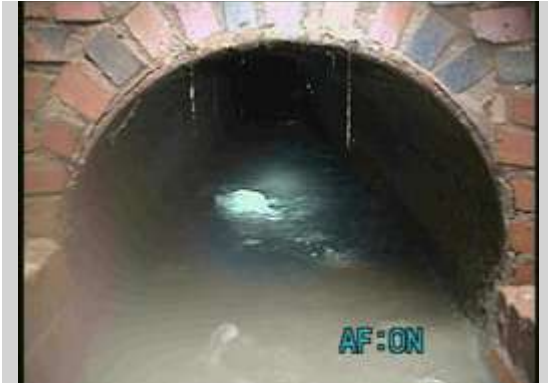
12 O'Clock Outflow

30 in. Circular Gravity Sewer  
Pipe Out @ 12 O'Clock

Invert Depth: 12.25 (ft.) Flow Characteristics: **Slow**

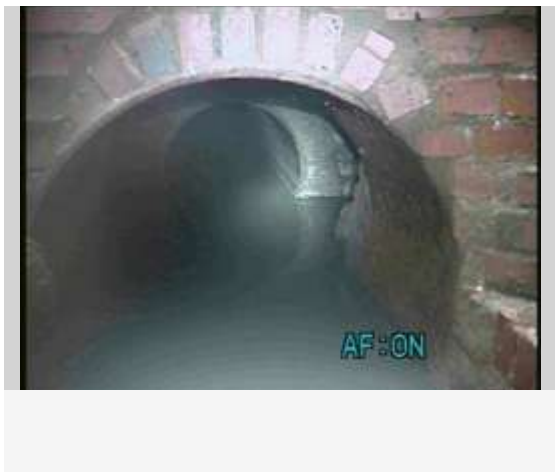
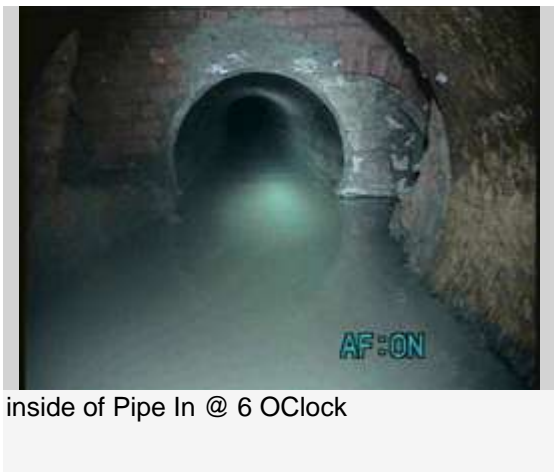
6 O'Clock Inflow

30 in. Circular Gravity Sewer  
Pipe In @ 6 OClock
